MINISTRY OF CULTURE AND SPORTS
EPHORATE OF ANTIQUITIES OF PREVEZA

ANCIENT THEATER OF CASSOPE SPONSORSHIP FILE

PREVEZA / DECEMBER 2014

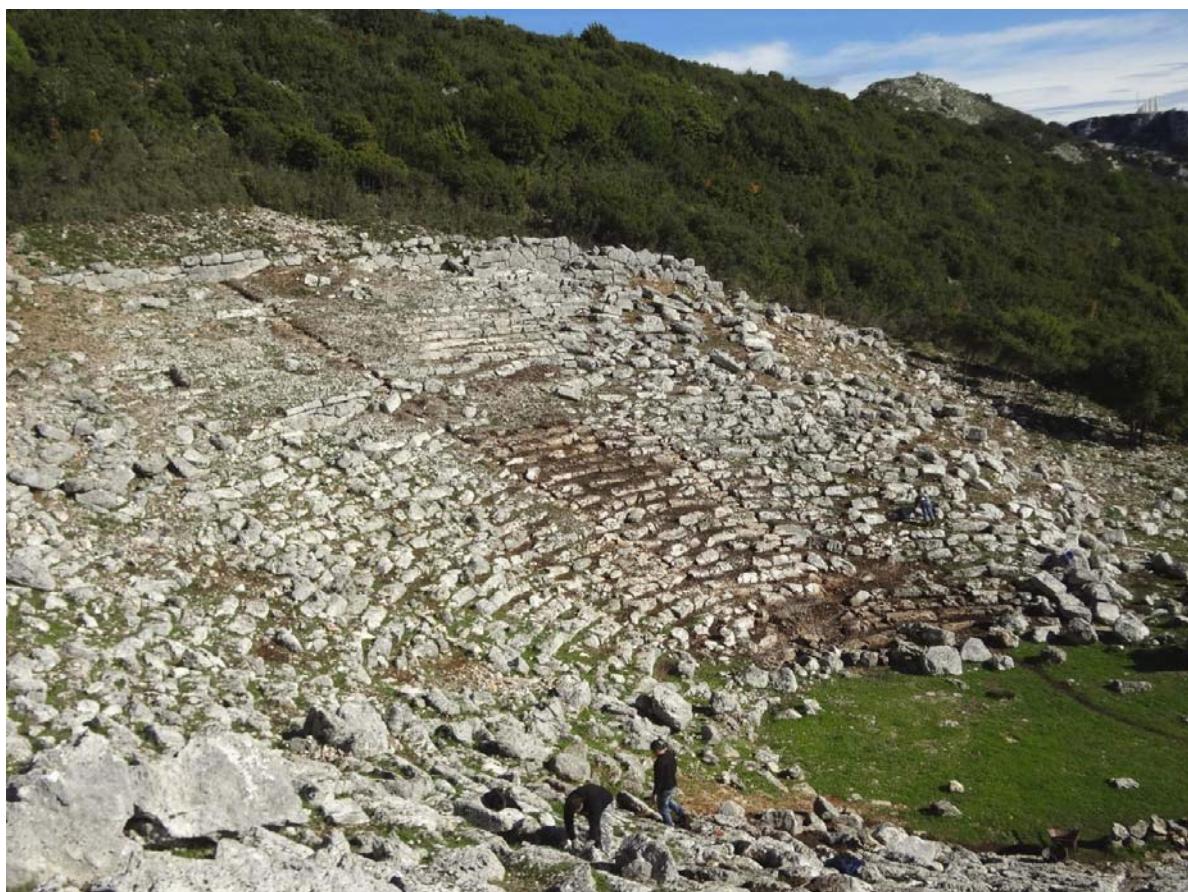
7. Revealing raw lines and preserved seats during the deforestation works.
(photo: Diazoma/2012)

The arc-shaped auditorium is slightly smaller than a semicircle and has a maximum diameter of about 82 m. and a particularly noticeable incline. All seats are attached on the natural rock and are made of local limestone, as one can see macroscopically. It is estimated that the auditorium could accommodate approximately 6,000 spectators. The theater was constructed following purely the Greek theater design principles. Based on the present excavation data there is no evidence of significant phases of rearrangement or conversion throughout the subsequent periods. Ten rows of radially arranged staircases divide the seats along the periphery of the auditorium into nine tiers. A passage (diazoma) intersecting the aisles also divides the seating area into two sections, up and down. According to visual observations, the lower section has twenty-three rows of seats and the upper section (epitheater) has eleven rows of seats. The documentation of these geometrical data may be verified scientifically in the future, since the architectural members of the auditorium have been displaced in a small or larger scale.

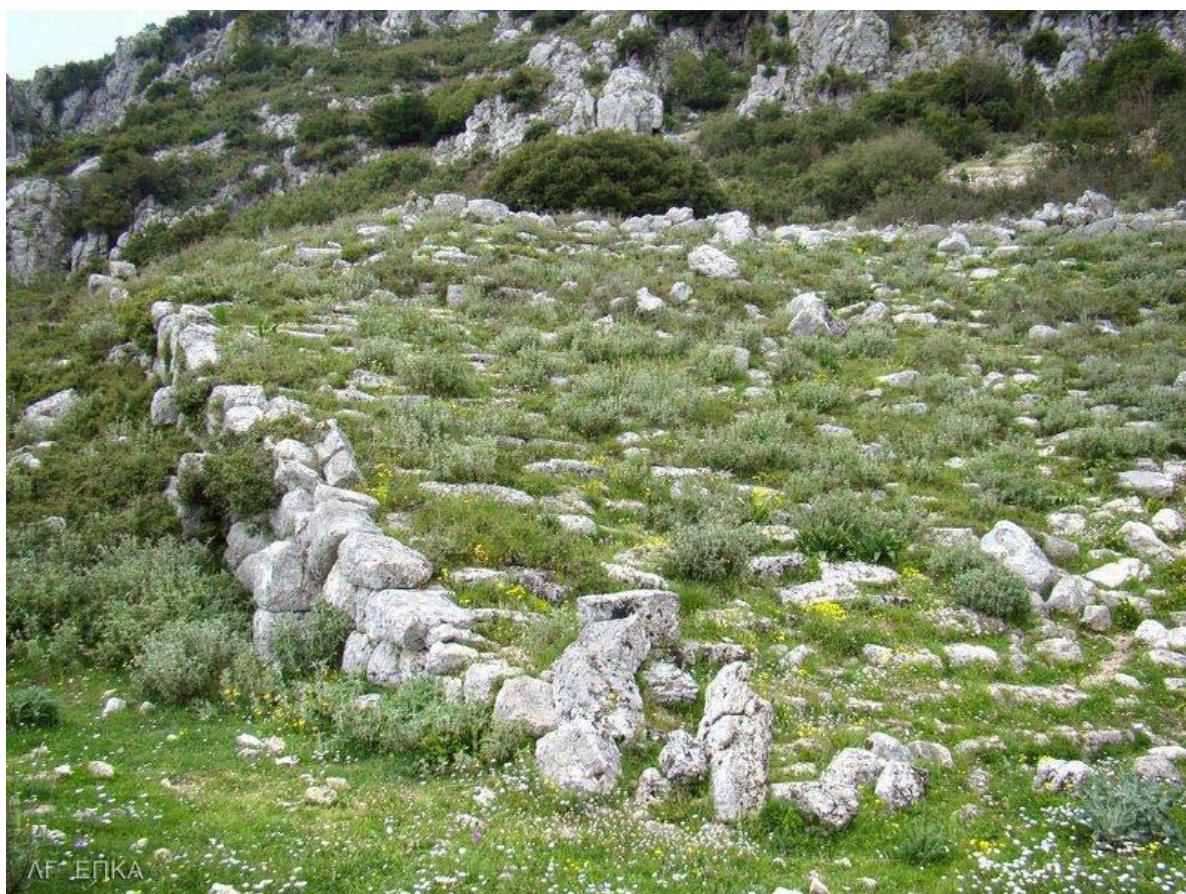
8. General view of the western retaining wall of the auditorium before the deforestation works.
(source: www.diazoma.gr)

The auditorium is bounded on both ends by strong retaining walls, structured with large stones following the system of polygonal masonry – the main structural feature of buildings of ancient Cassope. The walls bear inherent supporting struts at regular distances. At the top of the upper auditorium runs a corridor bounded by an outer perimetric wall built in the masonry technique of the island of Lesvos. On the eastern side of the perimetric wall, a small door-like opening has been detected. It is possible that future works might reveal the location of similar openings in the sections of the central or/and the western part of the perimetric retaining wall. S. Dakaris too refers to an extra opening in the upper levels of the auditorium. He believes that the layout and the carved quoins on the western edge of the middle tier means that there was a door there leading to an external staircase, similar to that of the theater of Dodona. Besides the theater of Cassope is typologically very similar to the Dodona theater in that important sanctuary of the time. This fact makes many to believe that the two theaters were constructed in about the same period, placing the erection of Cassope's theater in the early 3rd century B.C.

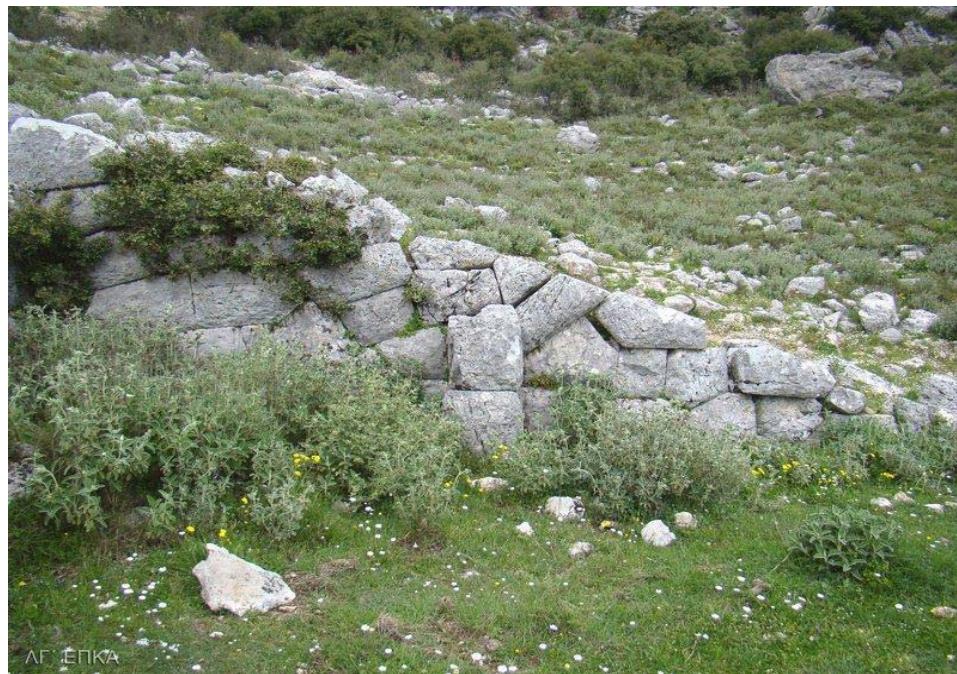
9. Detail of the western retaining wall of the auditorium before the deforestation works.
(source: www.diazoma.gr)

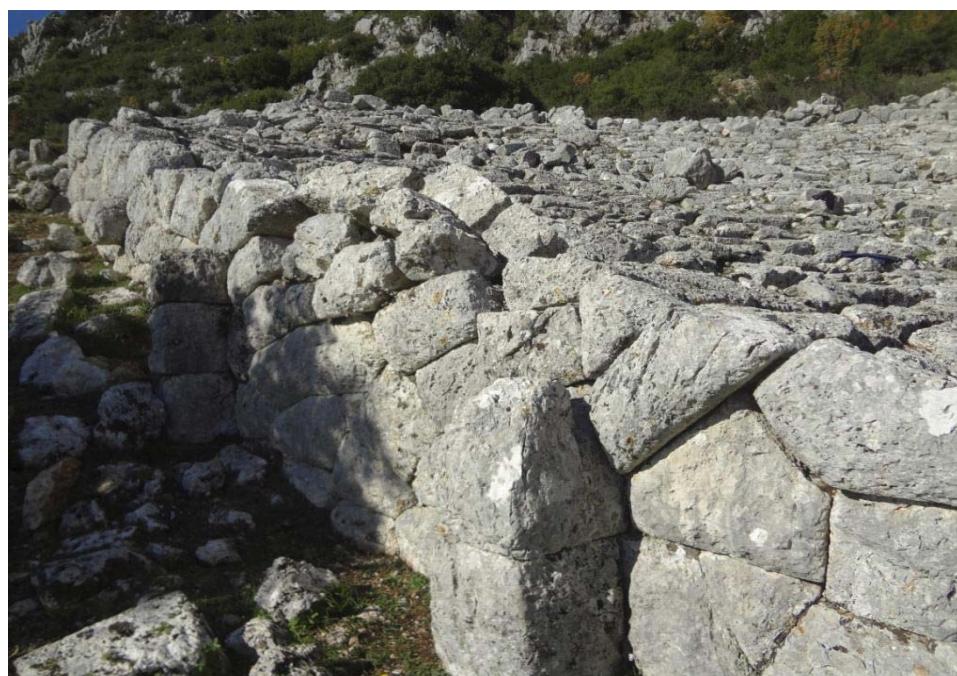
10. Detail of the western retaining wall of the auditorium after the deforestation works.
(photo: Diazoma/2012)

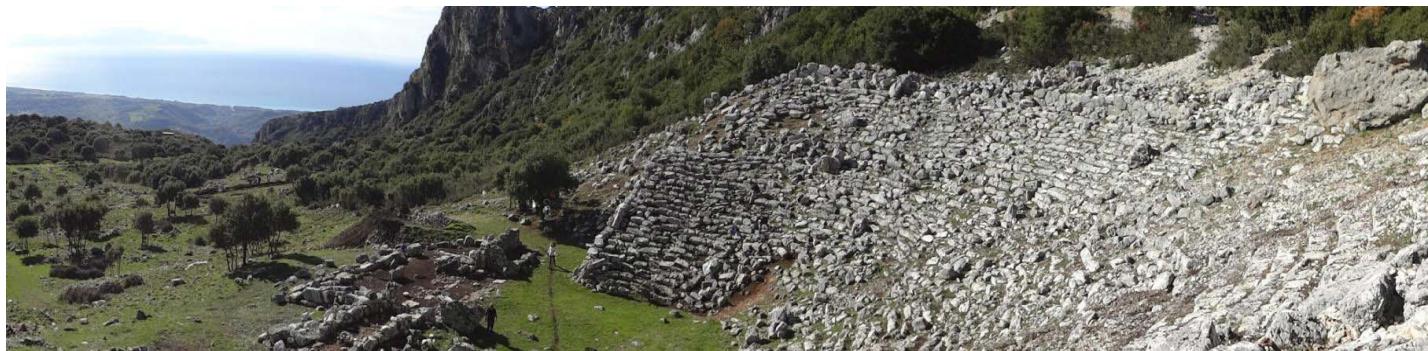
14. View of the eastern section of the auditorium after the deforestation works of 2012-2014 and the prior works for the removal of the fallen rock. (photo: Διάζωμα/2012)
